7 CULDUIE  
STRATHCARRON  
IV54 8LX

# Home Report

# Scottish Single Survey

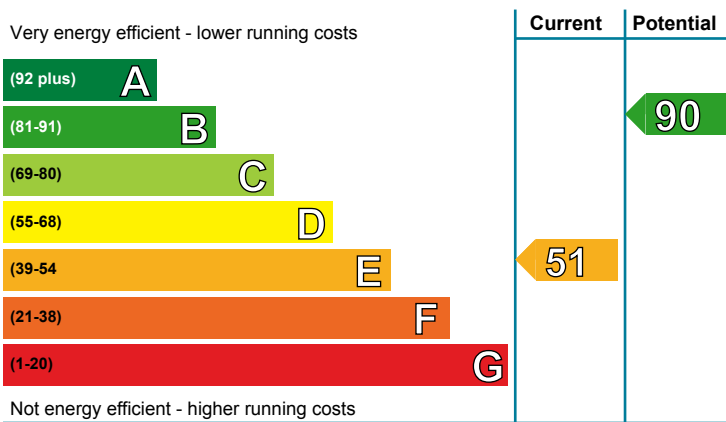
### Energy Efficiency Rating

This graph shows the current efficiency of your home, taking into account both energy efficiency and fuel costs. The higher this rating, the lower your fuel bills are likely to be.

Your current rating is **band E (51)**. The average rating for EPCs in Scotland is **band D (61)**.

The potential rating shows the effect of undertaking all of the improvement measures listed within your recommendations report.

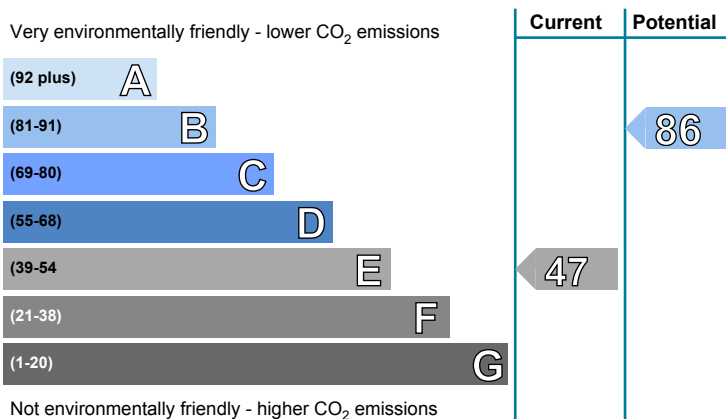
### Environmental Impact (CO<sub>2</sub>) Rating

This graph shows the effect of your home on the environment in terms of carbon dioxide (CO<sub>2</sub>) emissions. The higher the rating, the less impact it has on the environment.

Your current rating is **band E (47)**. The average rating for EPCs in Scotland is **band D (59)**.

The potential rating shows the effect of undertaking all of the improvement measures listed within your recommendations report.
